Experiences on Target/Instrument Installation at J-PARC

Masatoshi FUTAKAWA
J-PARC Center

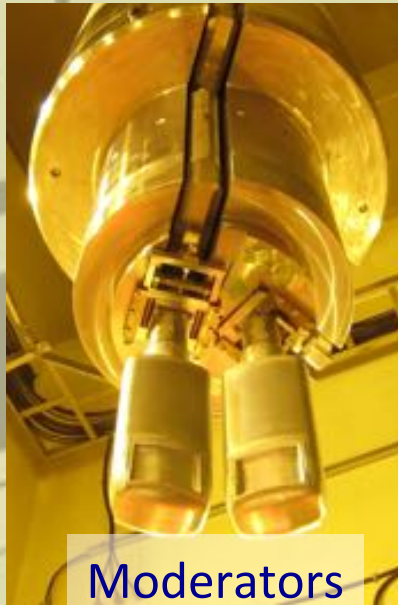
Moderators

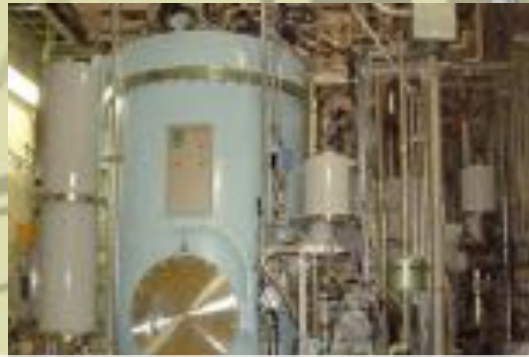
Cryogenic hydrogen system

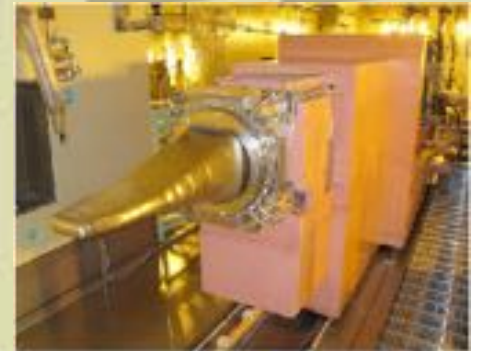
Mercury target system

Proton beam
3 GeV, 1MW, 25 Hz

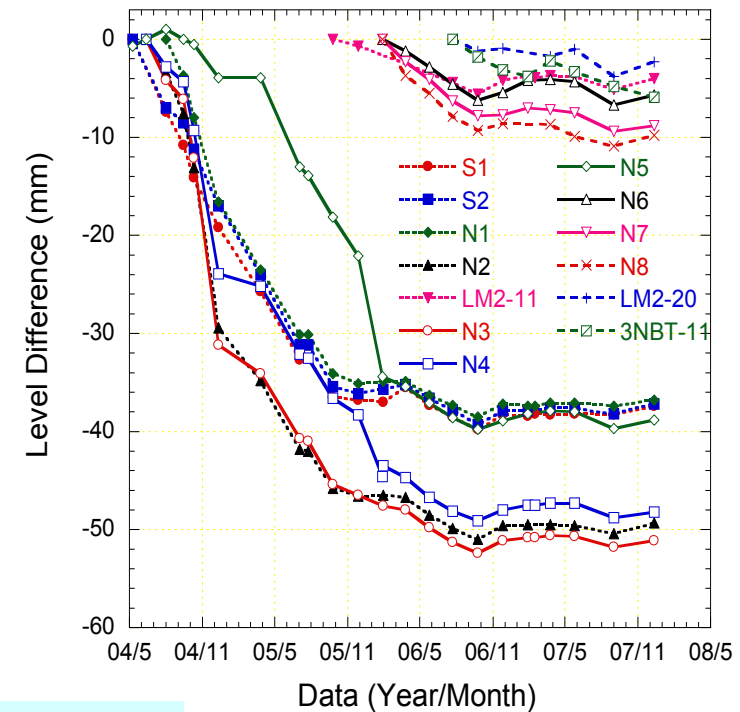
Level survey in BT tunnel
from RCS to MLF

Results of settlement survey in 3NBT tunnel

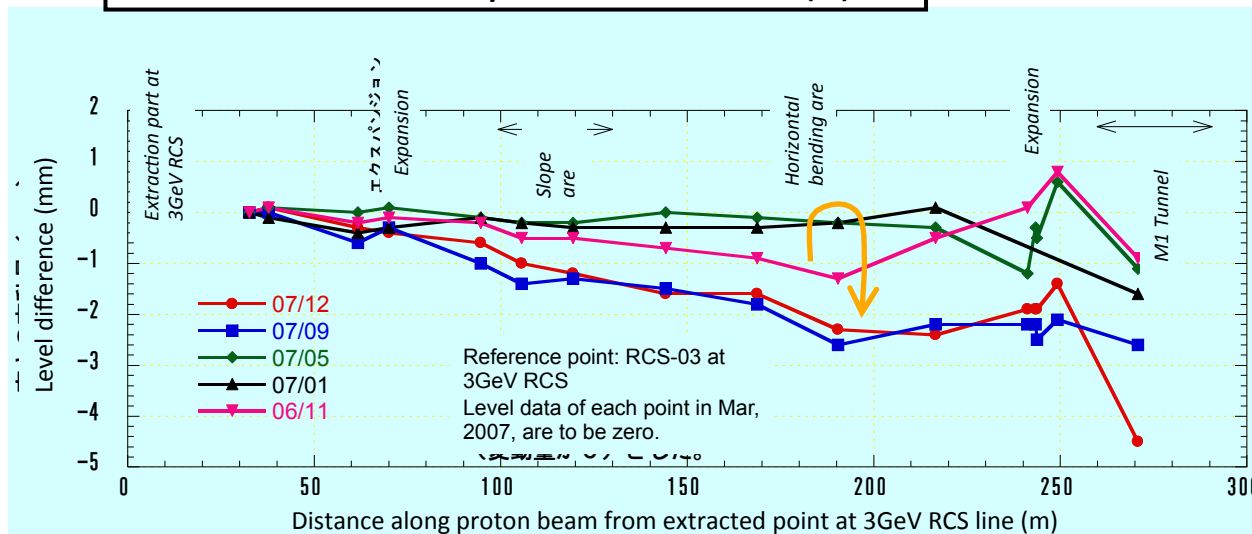
Result of the survey measurement (2)

The 3NBT tunnel, especially at the downstream, floated until January 2007. Then, it sank unit December, 2007. Even after the precise alignment in July, 2007, the downstream area in 3NBT slowly settles due to construction of neutrino beam line. Realignment would be necessary.

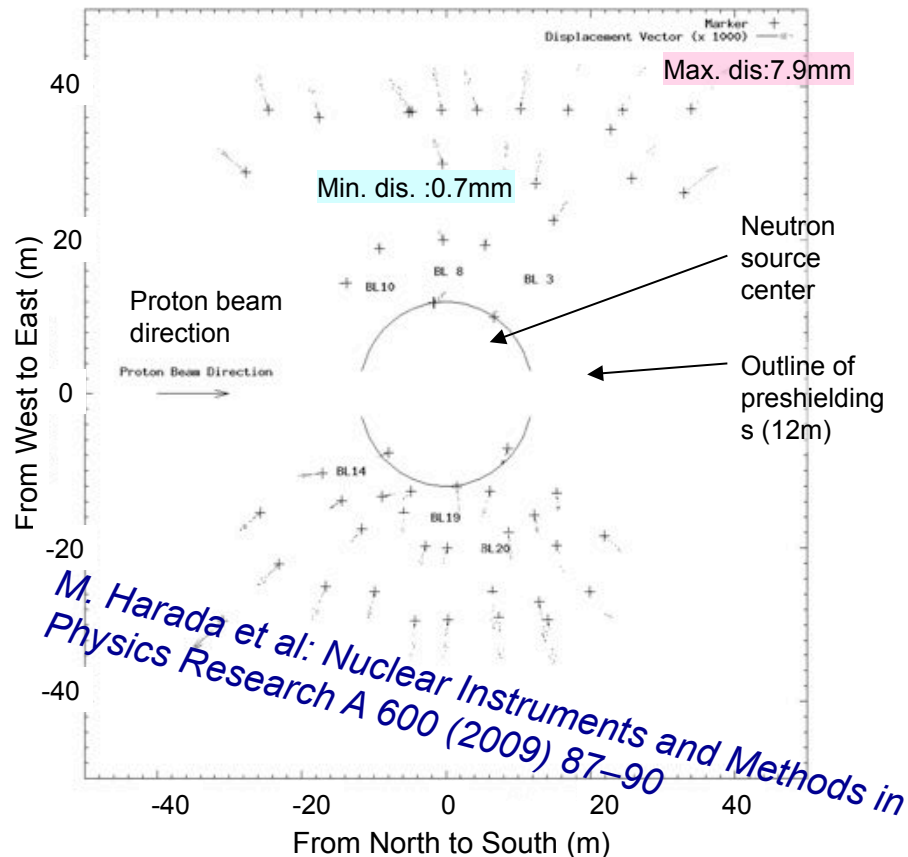
Horizontal displacement vectors of neutron beam line markers in the MLF experimental floor concrete

• Vector lengths were almost proportional to distances from neutron source center, it is thought that the concrete floor expanded thermally.

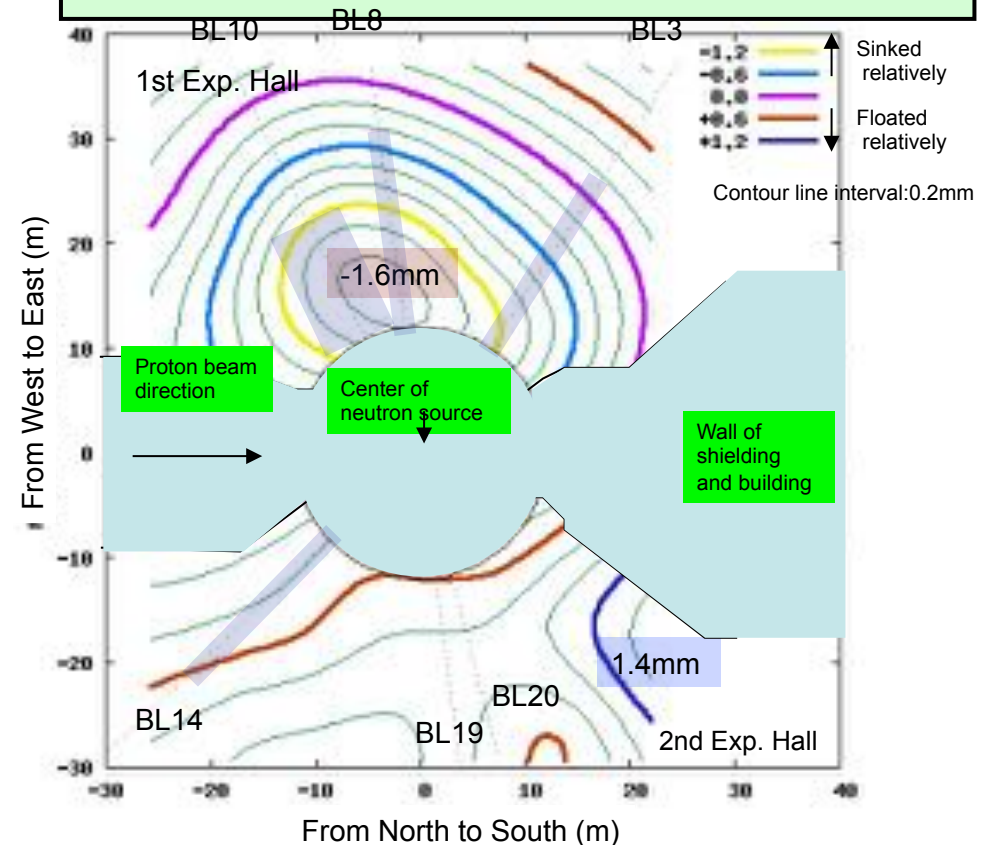
Uneven settlement of floor level in experimental hall in the period from Dec. 2006 to Oct, 2007

• 1st experimental hall floor sinks to 1.6 mm at maximum and 2nd one floats to 1.4 mm at maximum compared to the average value. The reason is that beam line shieldings at BL3, BL8 and BL10 are installed.

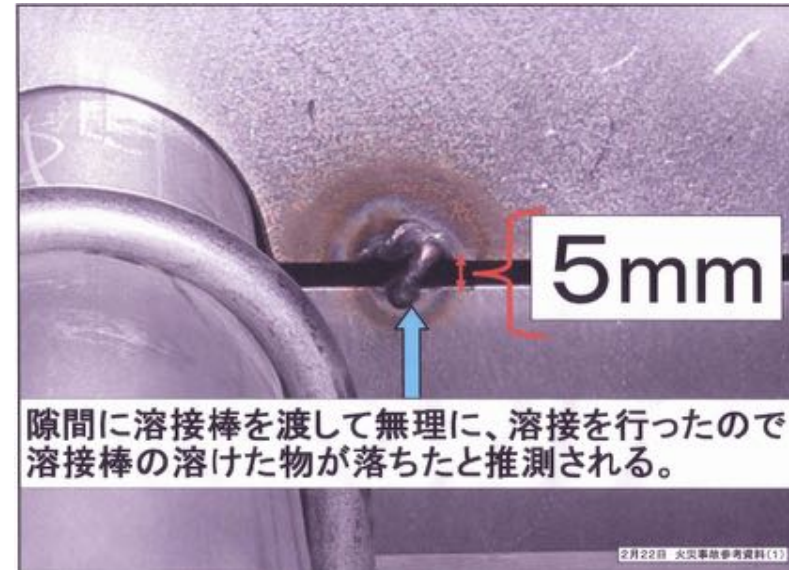
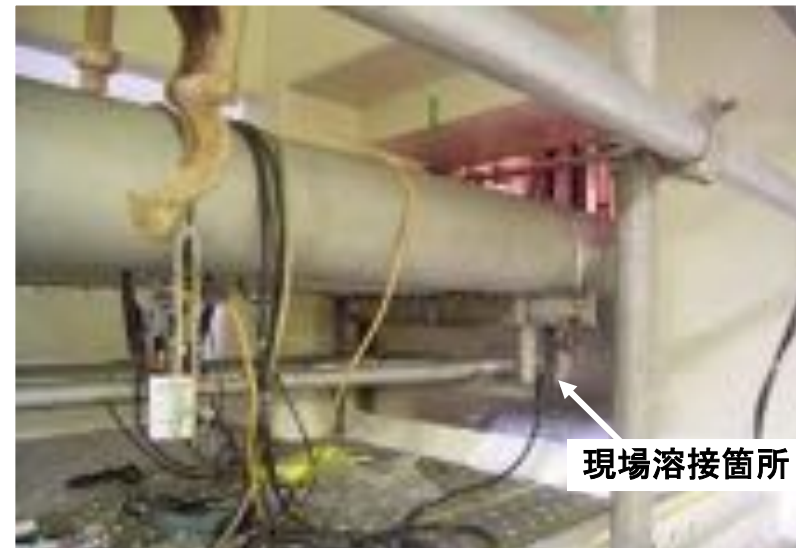
Welding on piping at MLF

- 知識に乏しい者がTIG溶接をした。
 - 板間の隙間大きく、溶接棒を渡す無理な溶接を行い、溶接棒の熔解物が下方に落下した。
- TIG溶接は安全と過信し十分な養生をしていなかった。
 - 作業者は、溶接火花が出ないので耐熱シートの養生シートなしで行えると思った。
- 持場を離れる時の火気確認が不十分であった。
 - 11時50分に溶接作業を終え、作業終了後の溶接作業に伴う安全確認を行わずに、12時に昼食のため現場を離れた。

溶接現場写真：現場溶接箇所には耐熱シート養生無し

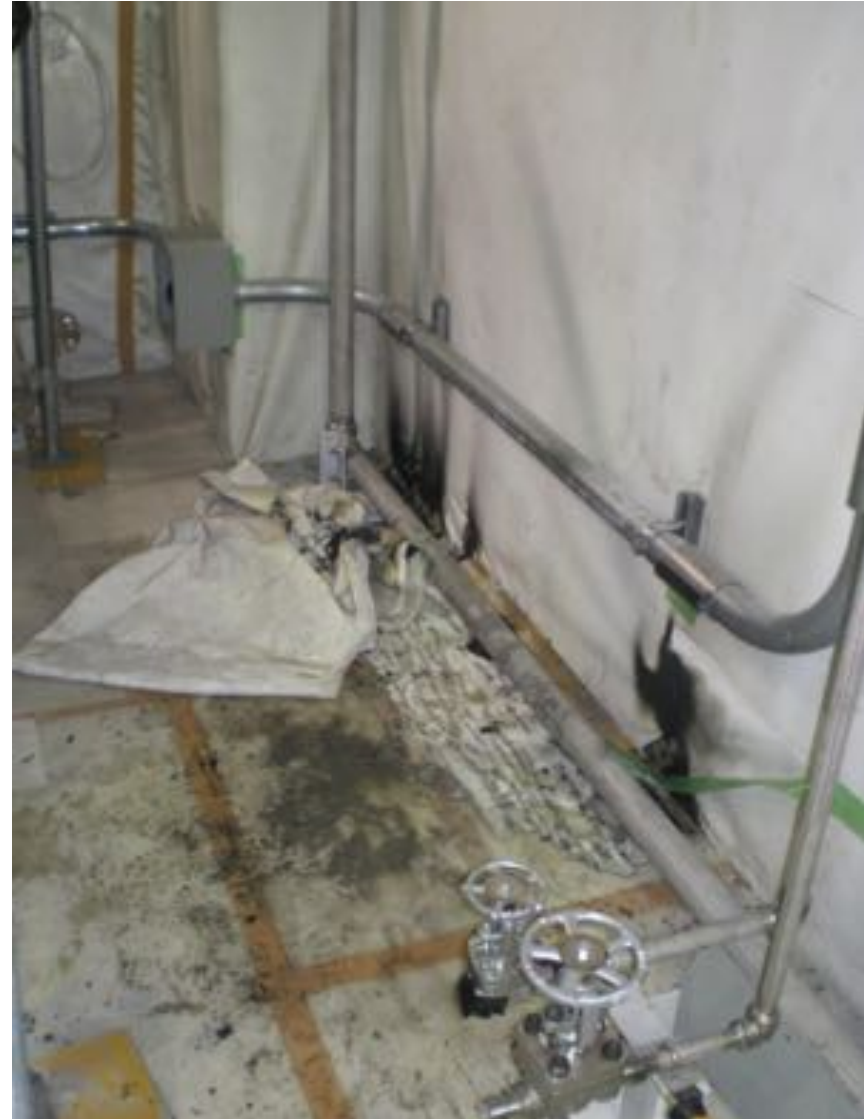
Fire of normal sheet by welding drop

- 平成19年2月22日12時10分、本溶接に直接関係のない別件の作業者が、気体廃棄物処理設備室前を通行時、異臭を感じ火災を発見した。
- 壁貫通仕舞いのSUS板溶接現場の溶接後の残り火が、床養生に引火し、発煙した。

気体廃棄物処理設備室の火災現場写真

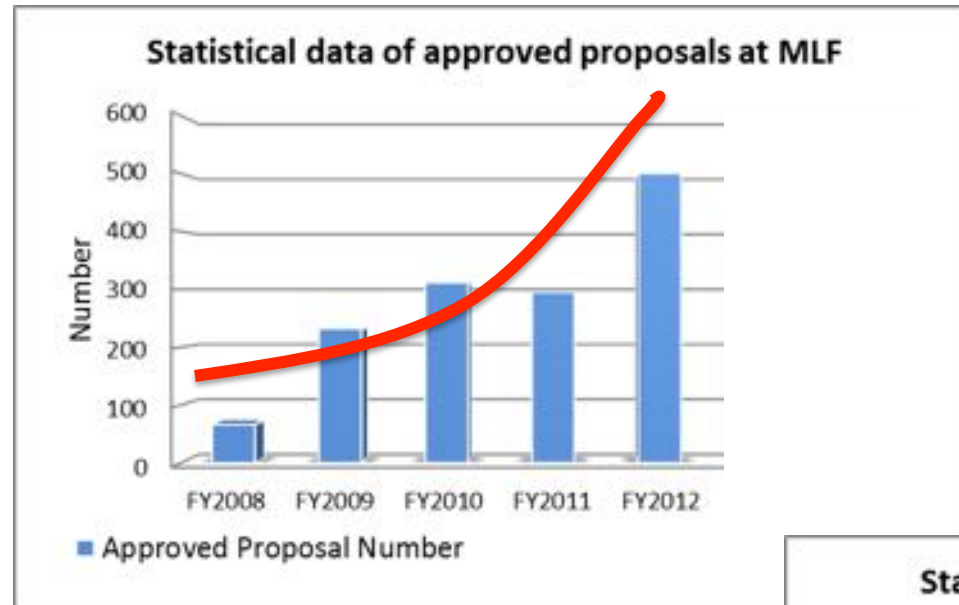
Statistical relation between proposal number and accident/incident number

Correlation between
No. of Proposals and
No. of accidents ?!

In the early stage period, most of the accidents are related to the neutron source, likely so-called early stage machine troubles.

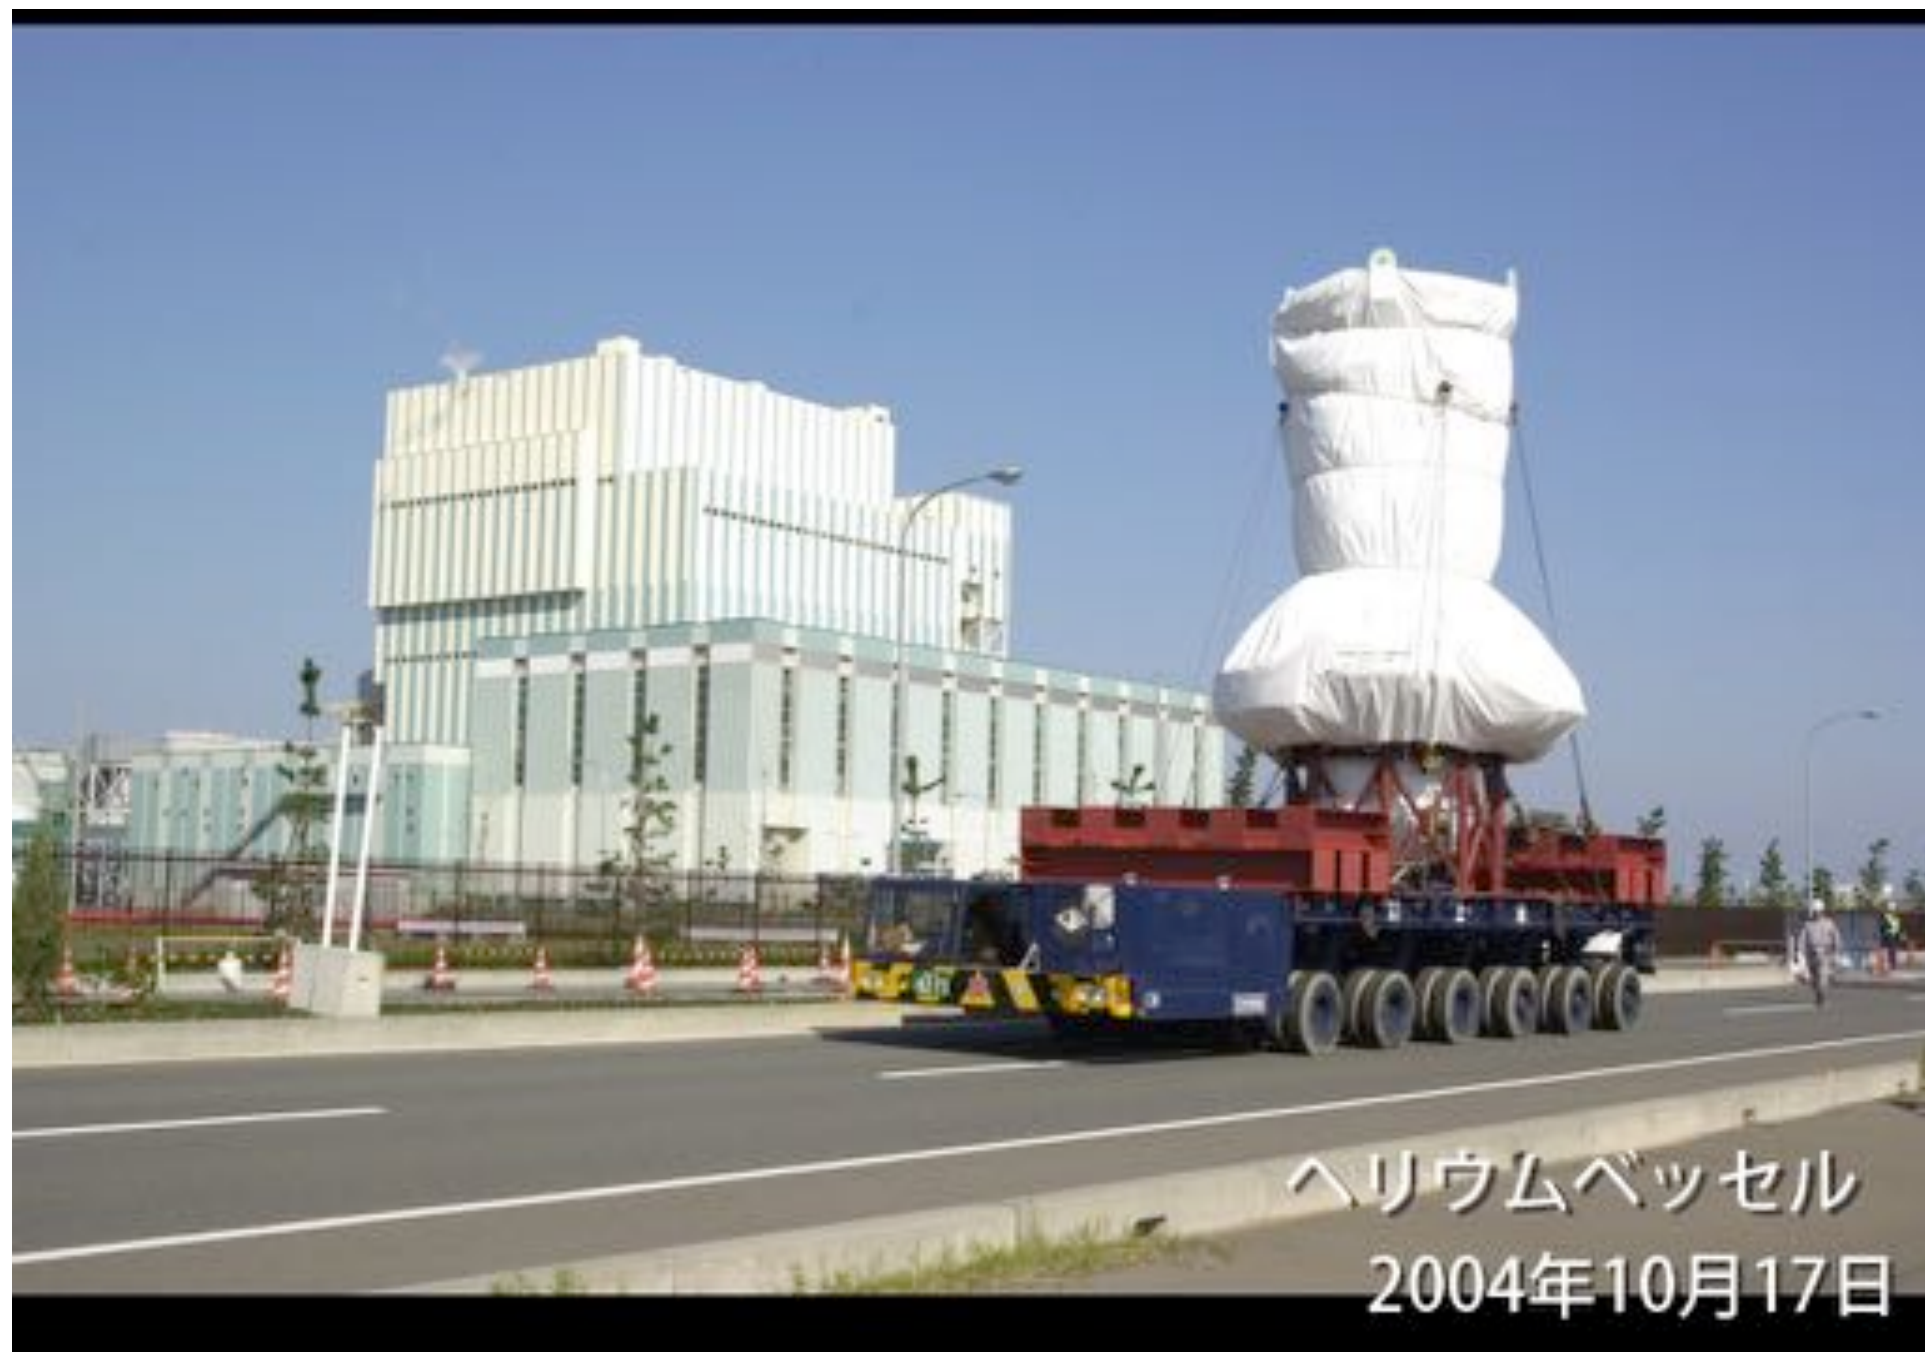
ヘリウムベッセル
2004年10月17日

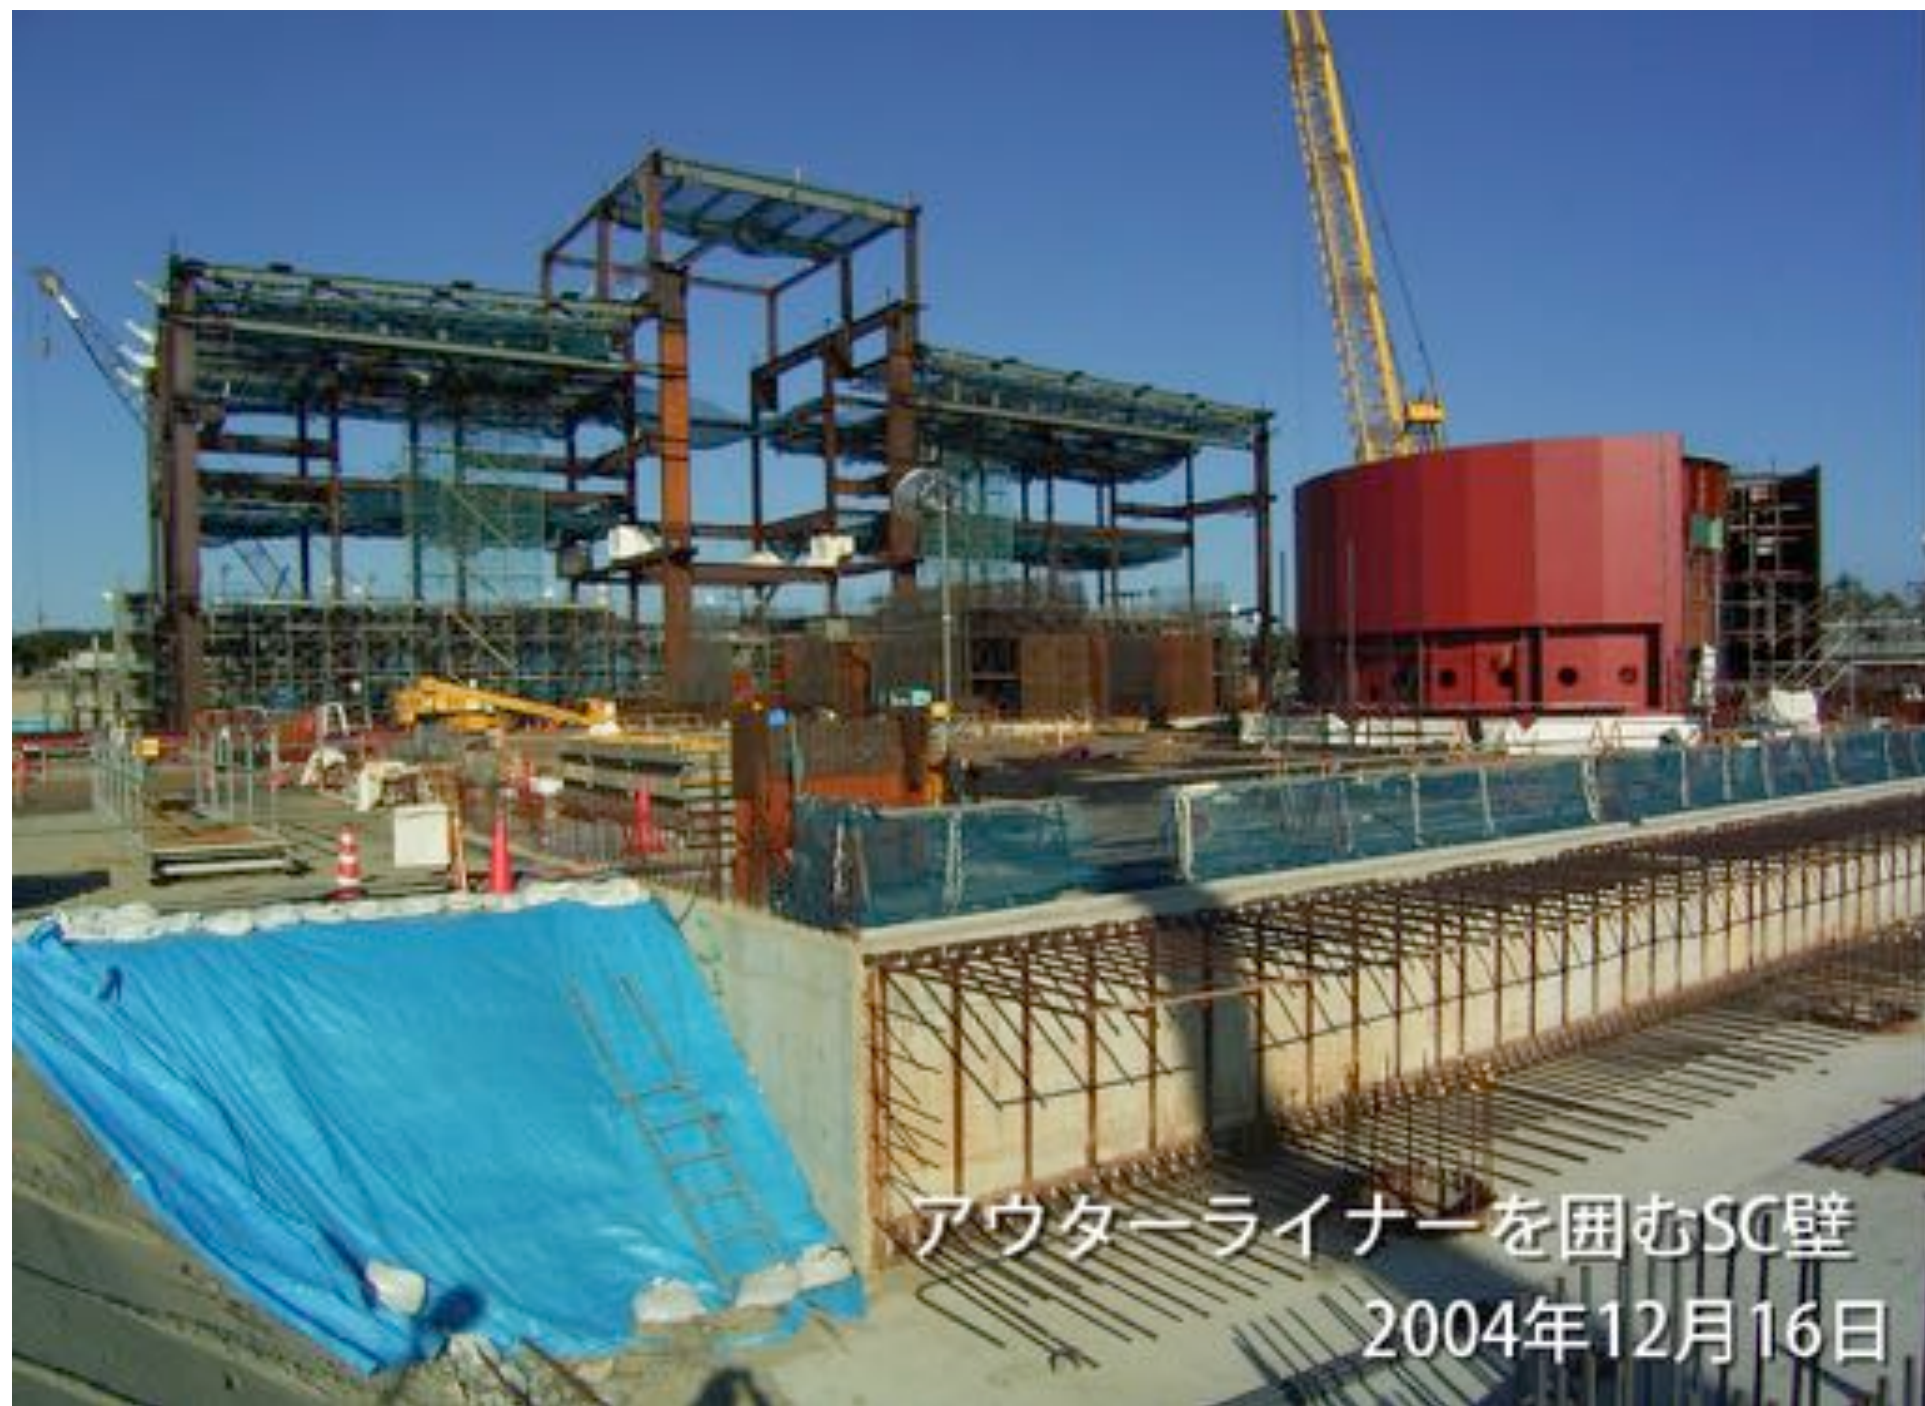
アウターライナーを囲むSC壁
2004年12月16日

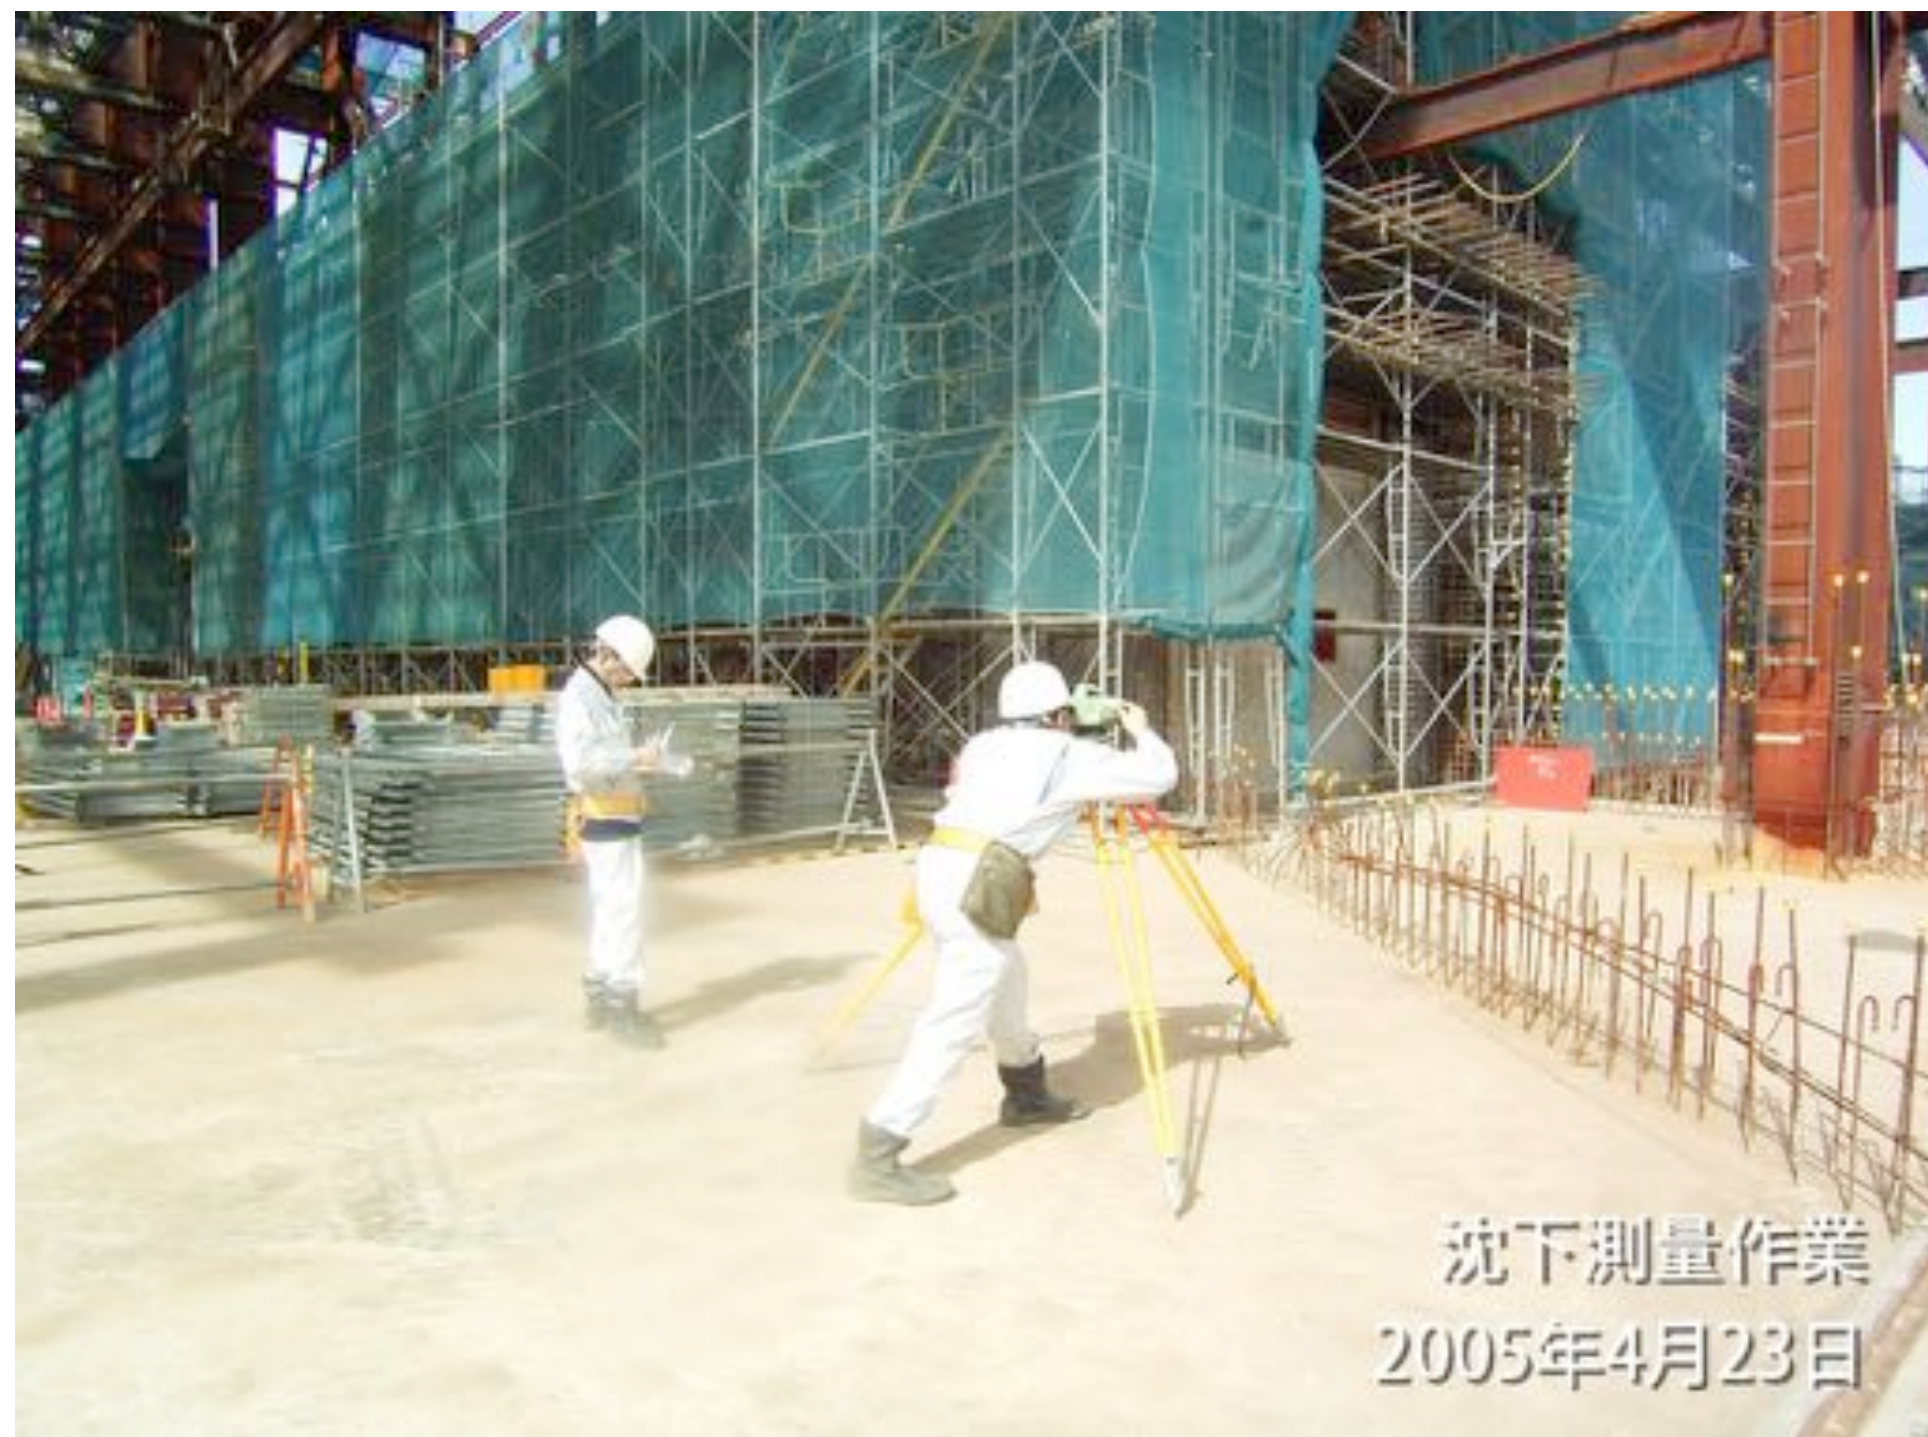
沈下測量作業
2005年4月23日

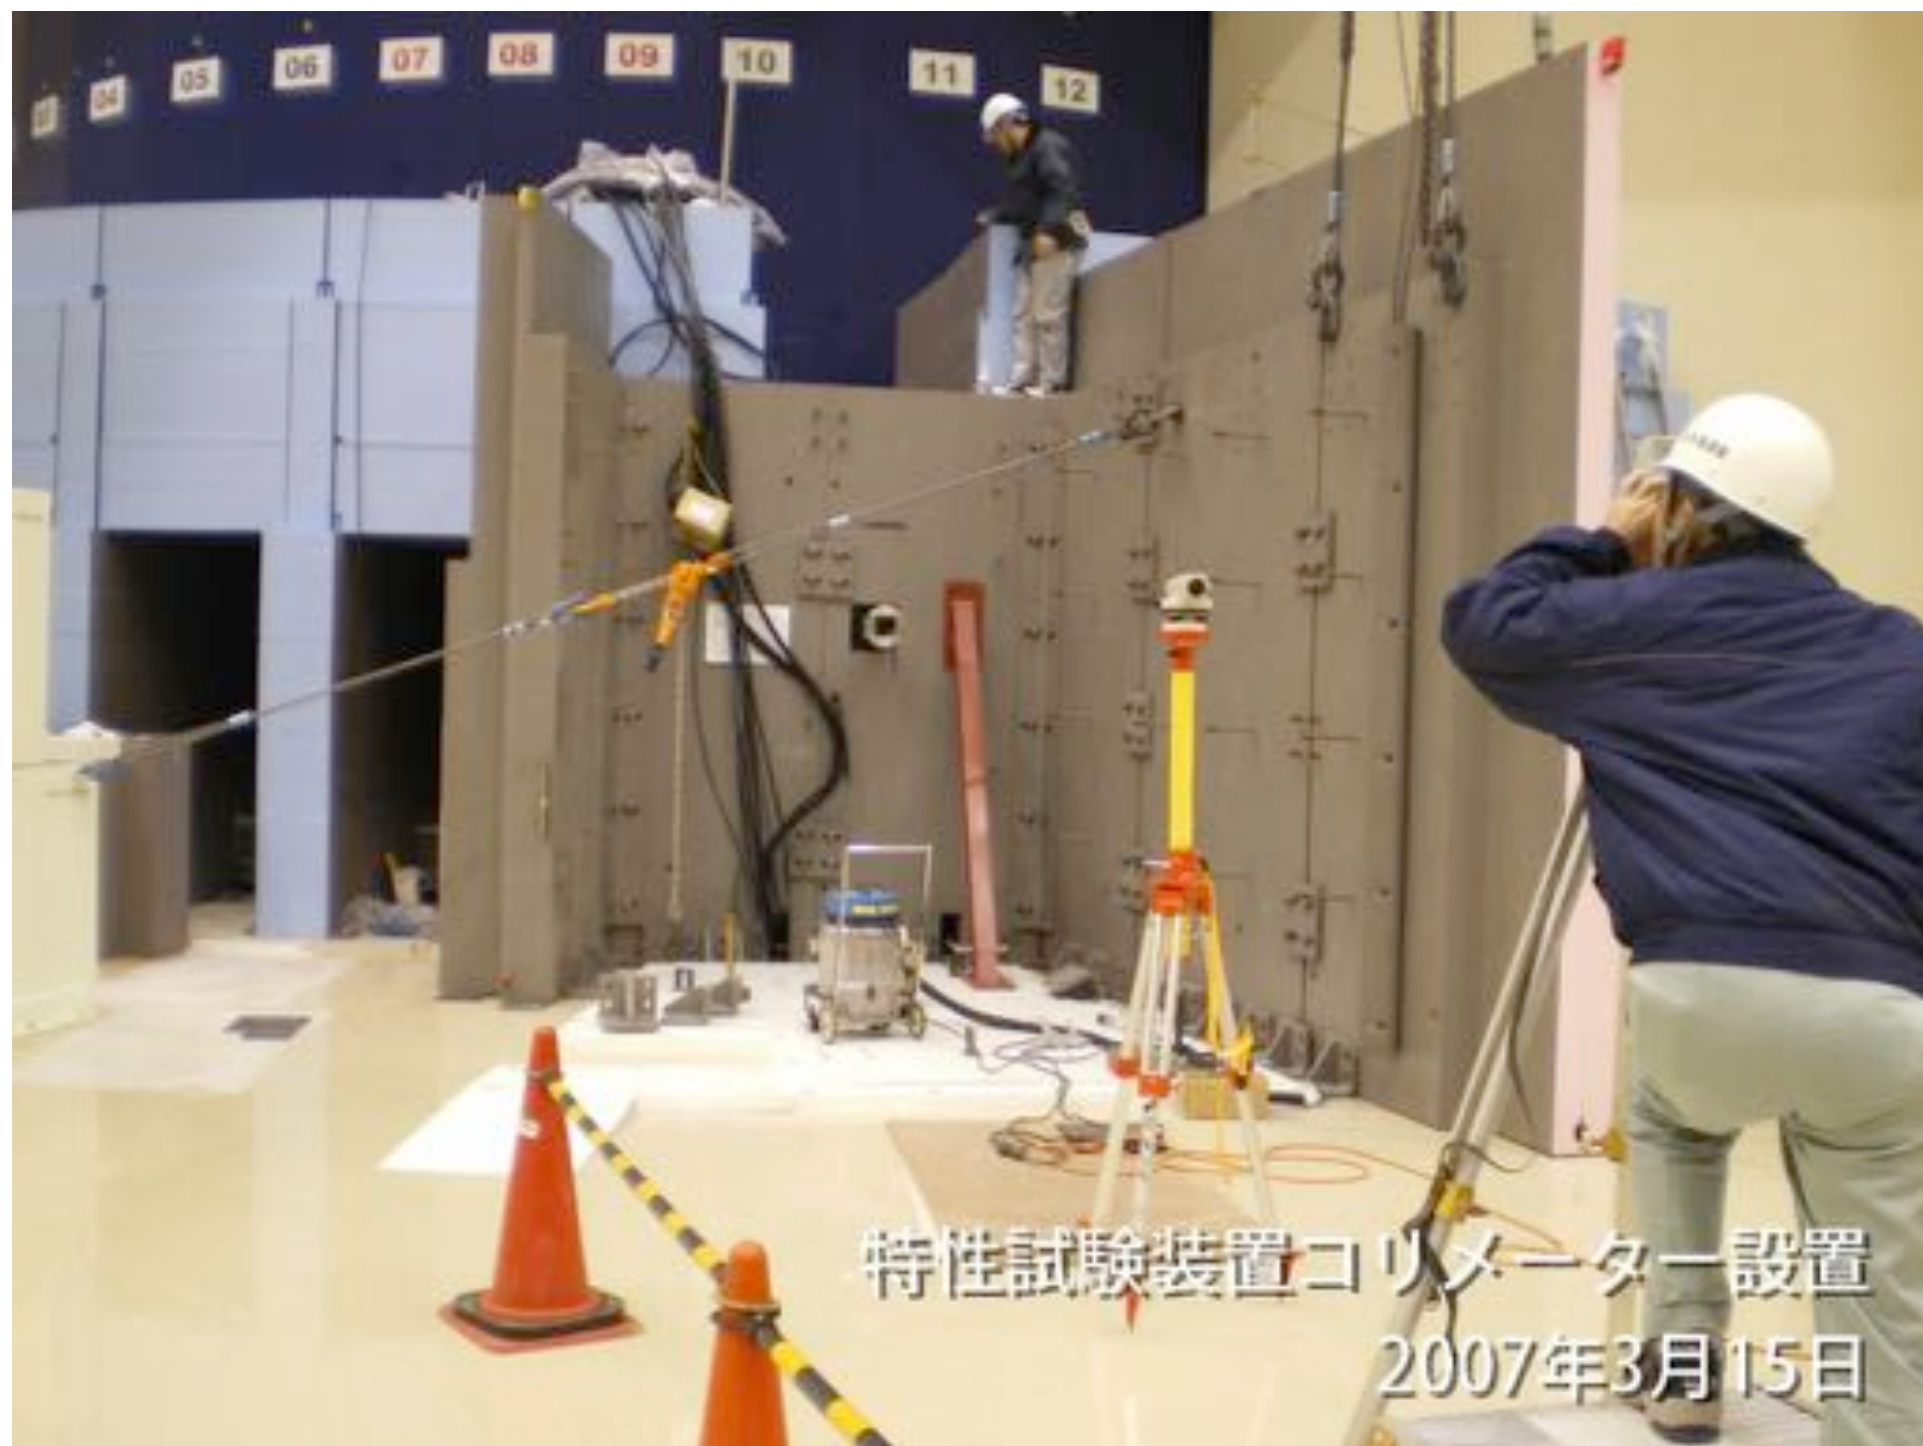
特性試験装置コリメーター設置

2007年3月15日

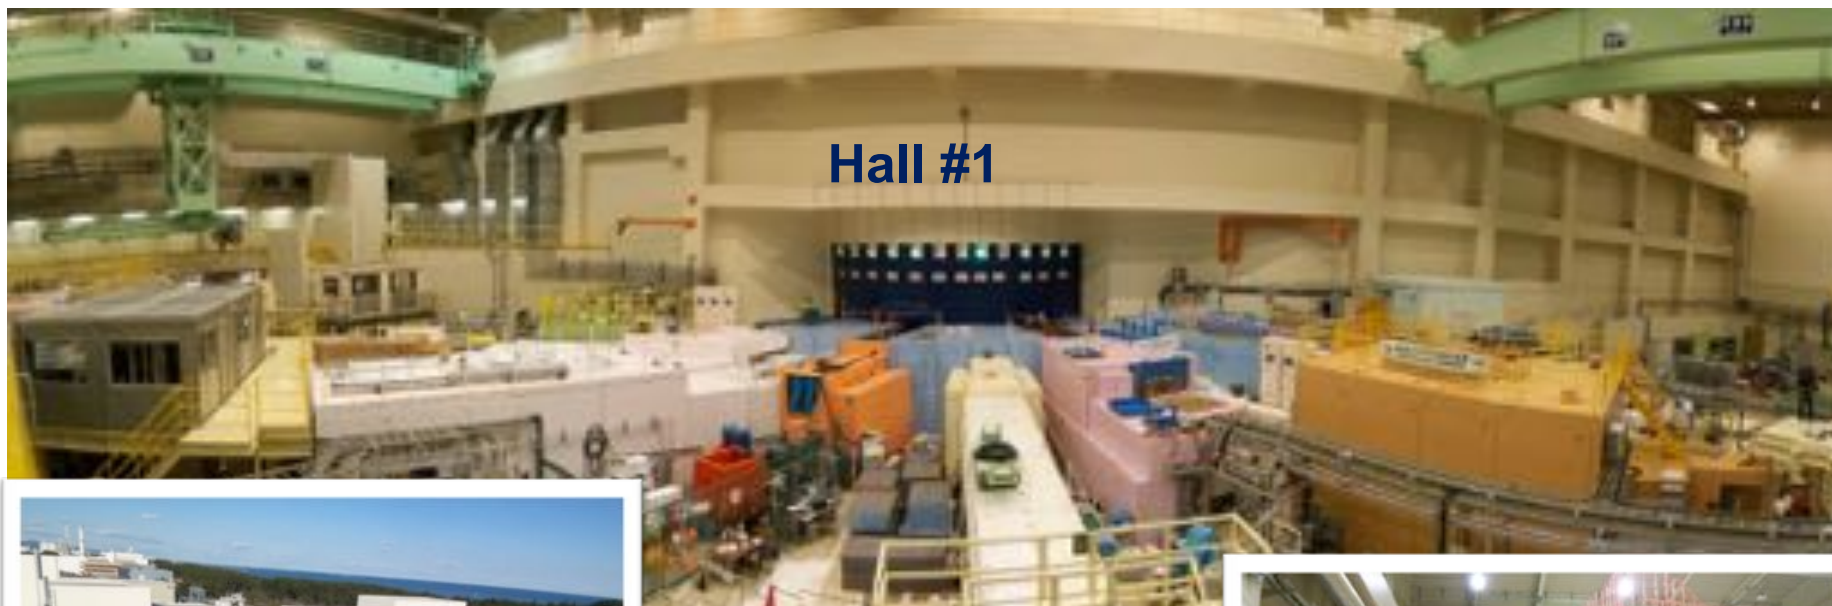
View in MLF

2011 Jan 7 (9 inst. oper. + 6 under const.)

Hall #1
